18/8/05 Engine T.O. Smealowse /  
dn. steps / fell over / & put  
in garage on tray w. wheels.

Removal of Internal Trim, Headlinings, etc.

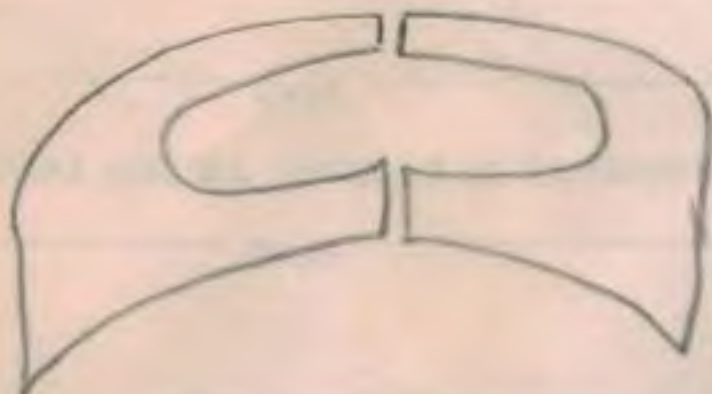
② When ① is off the covering to the rear window shelf can be removed.

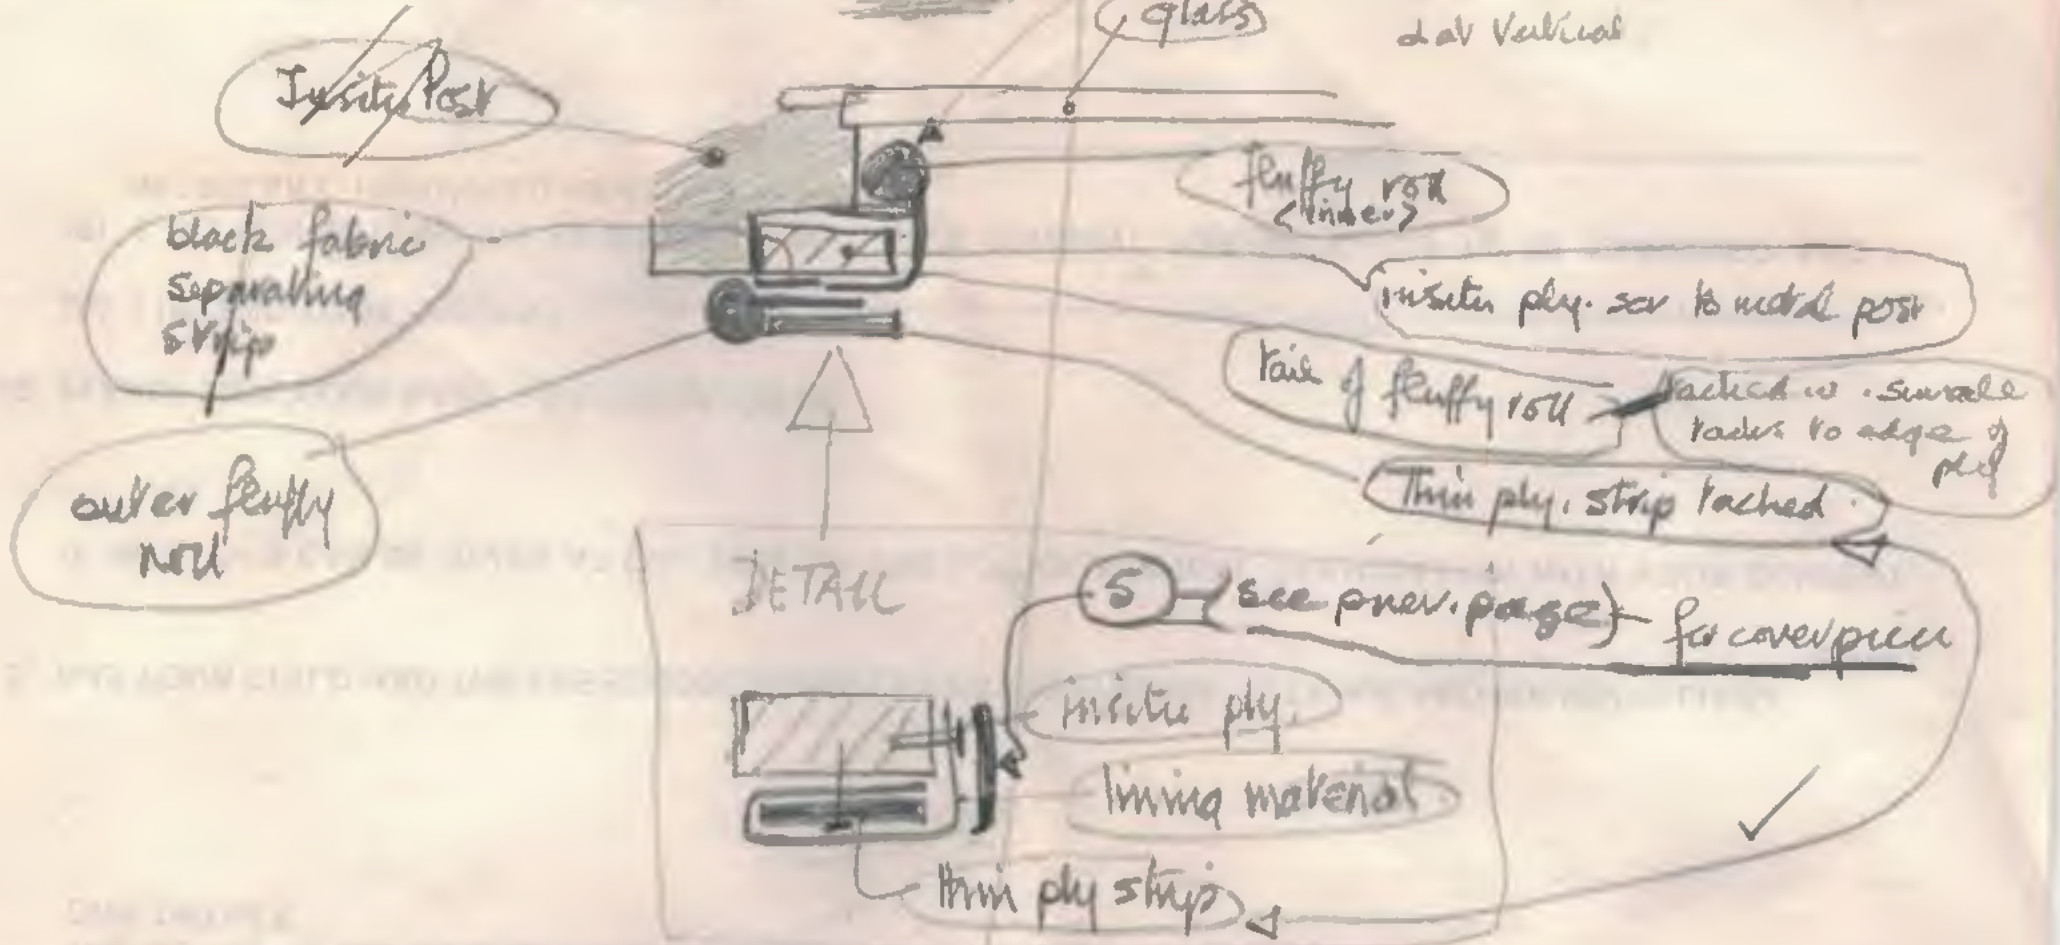
Front N/S window pillar. PLAN

After the removal of ⑤ there is a complicated arrangement for fixing the fluffy rolls & the narrow material-covered trim pieces (eg. side of head) together. (see next page)
